MEMOIRS OF AN AERONAUTICAL ENGINEER

**Flight Tests at Ames Research Center:
1940-1970**

Seth B. Anderson

National Aeronautics and Space Administration
Monograph in Aerospace History Series #26

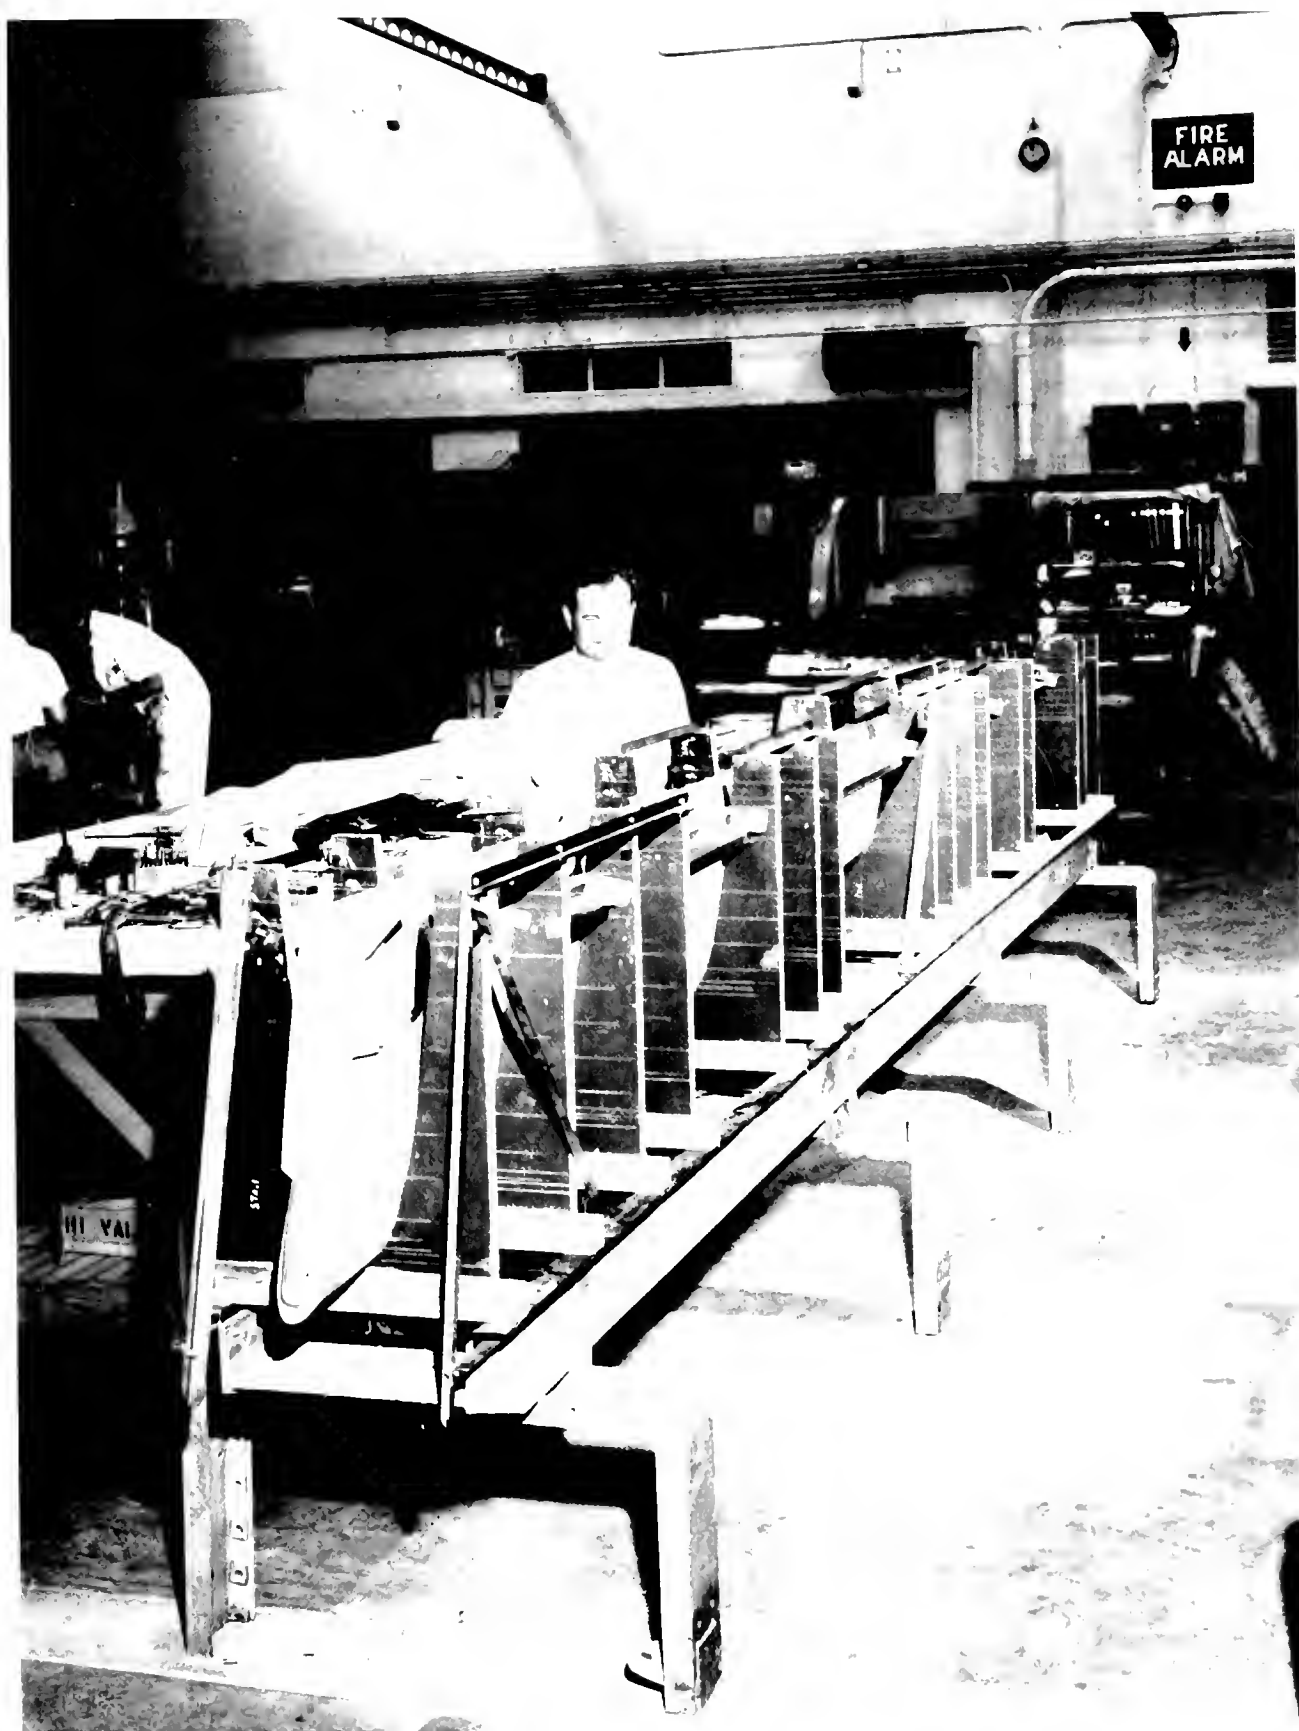
Figure 49. The wing leading edge of F-86 fighter was modified by Ames sheet metal shop using mahogany. Greater camber and leading-edge radius increased lift coefficient; stalling characteristics were still unacceptable. (May 1957) A-22658

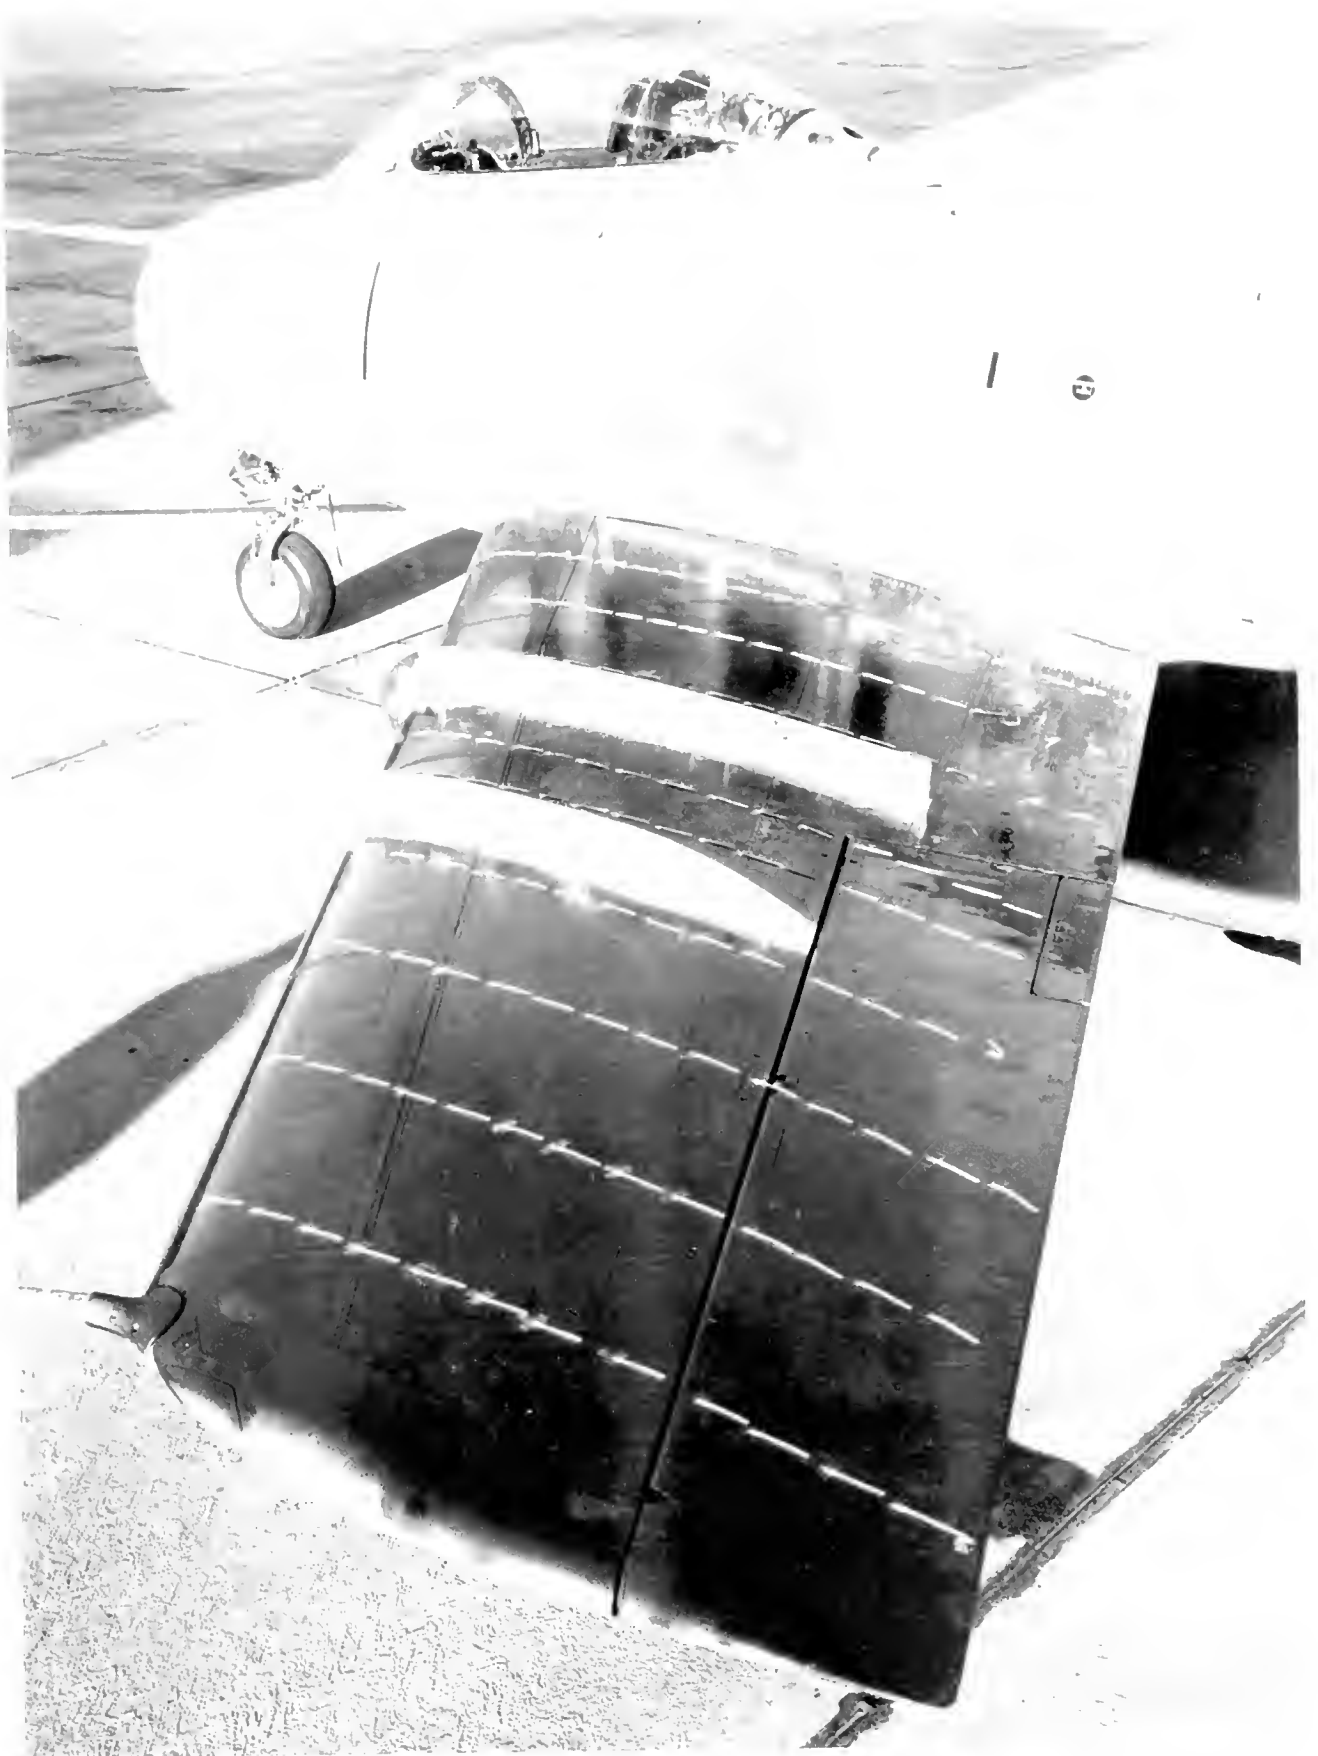
Figure 51. Multiple fences on F-86A wing reduced flow separation outboard with less roll-off at stall. Additional fences strongly reduced wing maximum lift. (Nov. 1952) A-17733

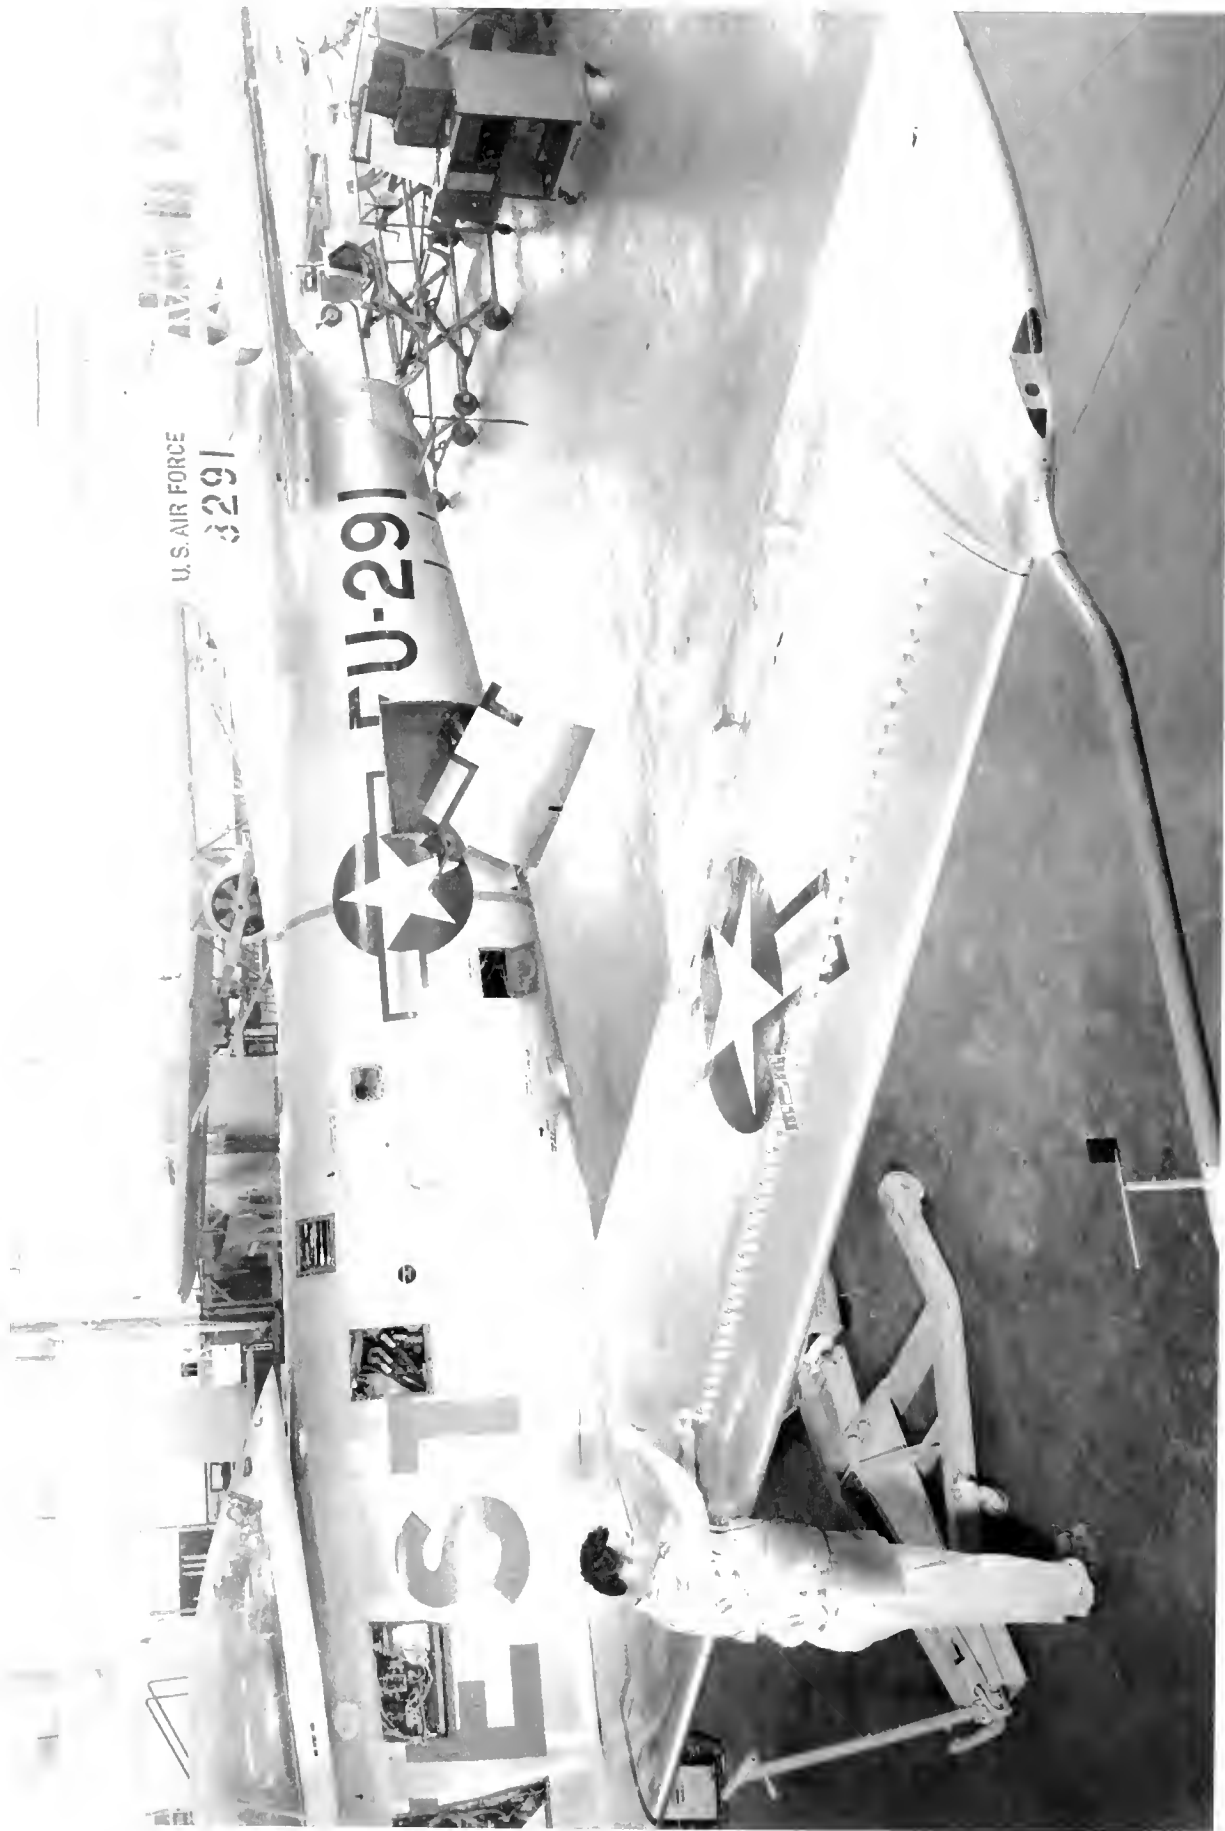
Figure 52. Vortex generators on the forward chord of the F-86 wing reduced flow separation at high transonic Mach numbers. Note the Fairchild F-24 utility aircraft used for test pilot training in the background. (Feb. 1952) A-16086

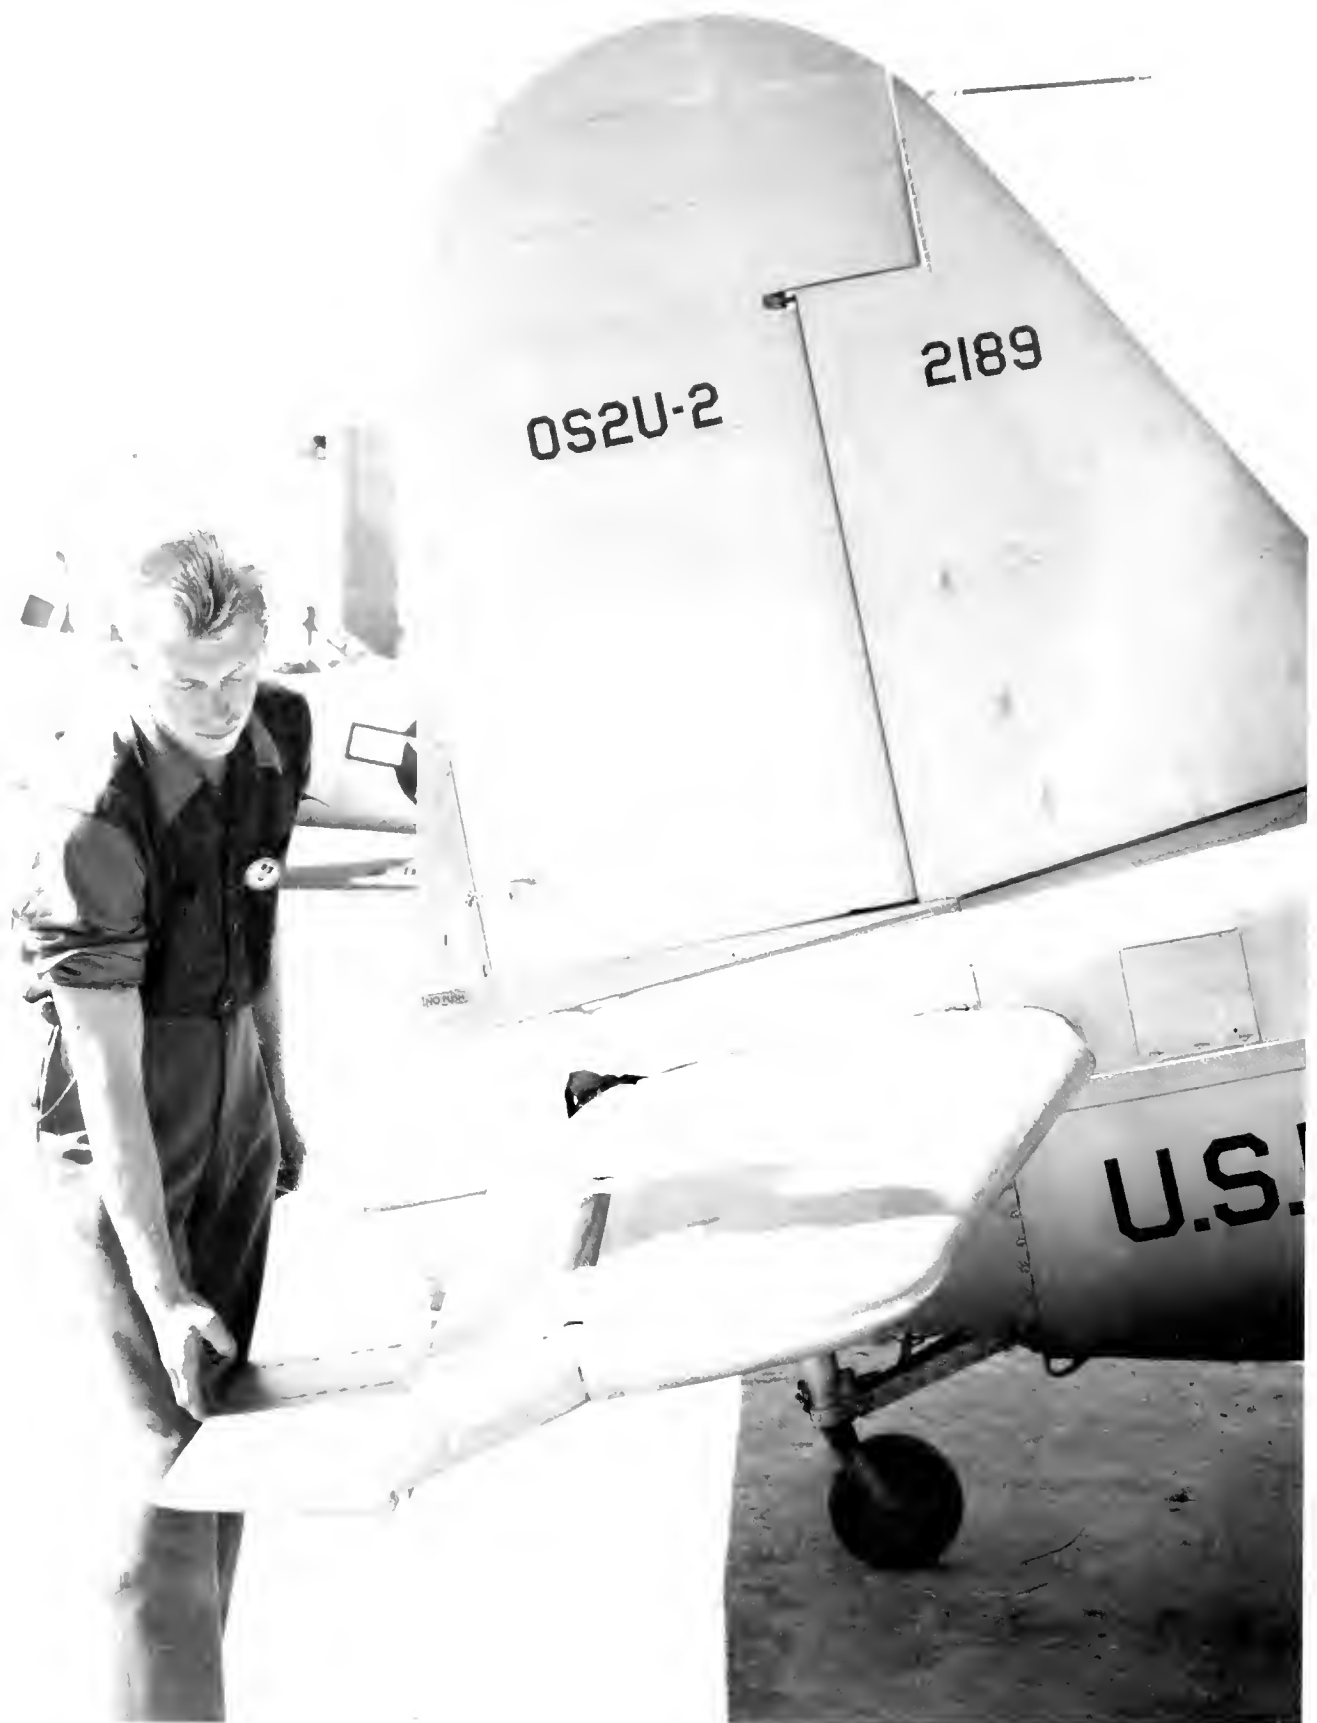
Figure 56 Ames-designed, double-hinged horizontal tail mounted on the OS2U-2 Kingfisher provided increased lift for maneuvering and landing (Vultee BT-13 in background). (Feb. 1945) A-7431

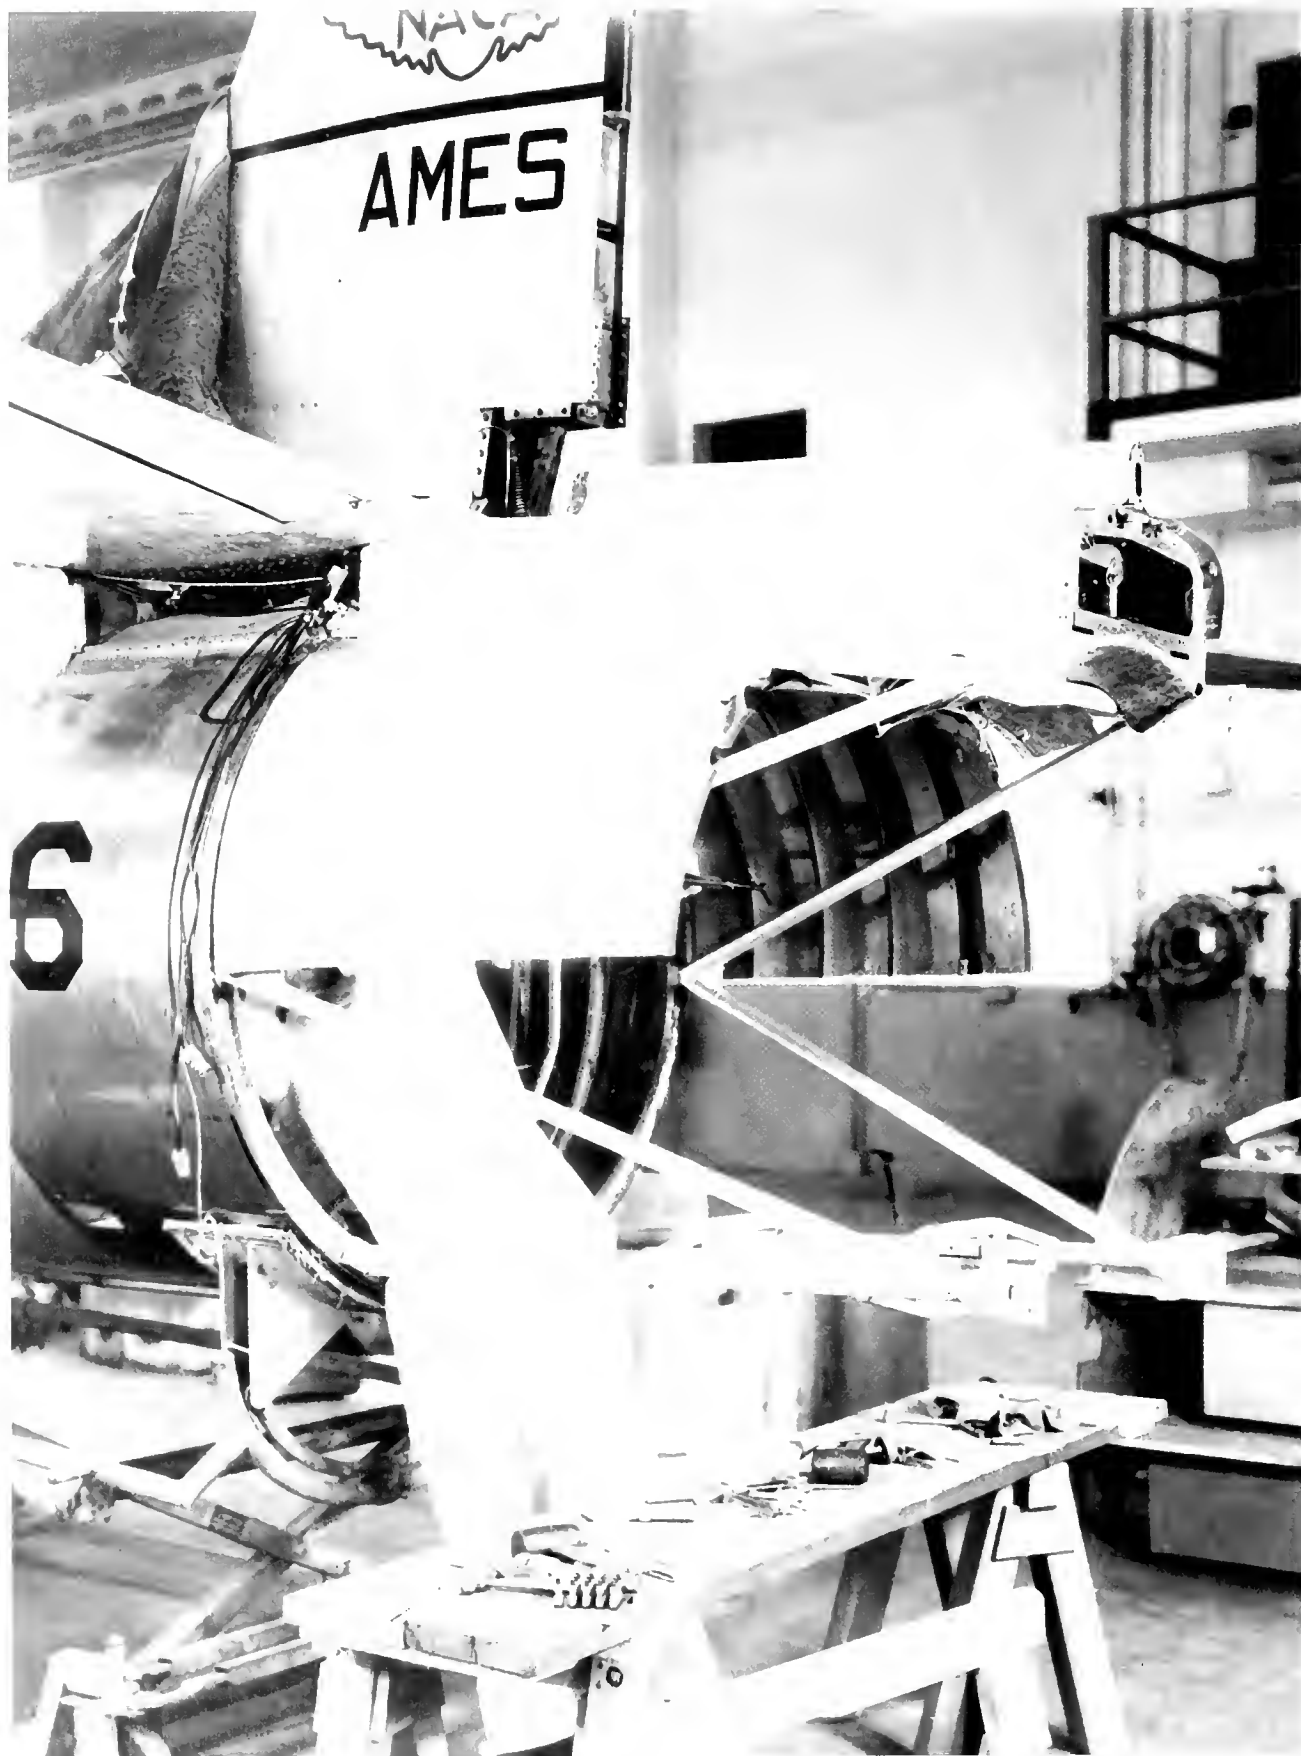
Figure 60 The F-94C's rear fuselage was modified in the Ames sheet metal shop to accommodate installation of Ames designed thrust reverser. Afterburner equipment used on the F-94C has been removed. (Aug. 1957) A-22727

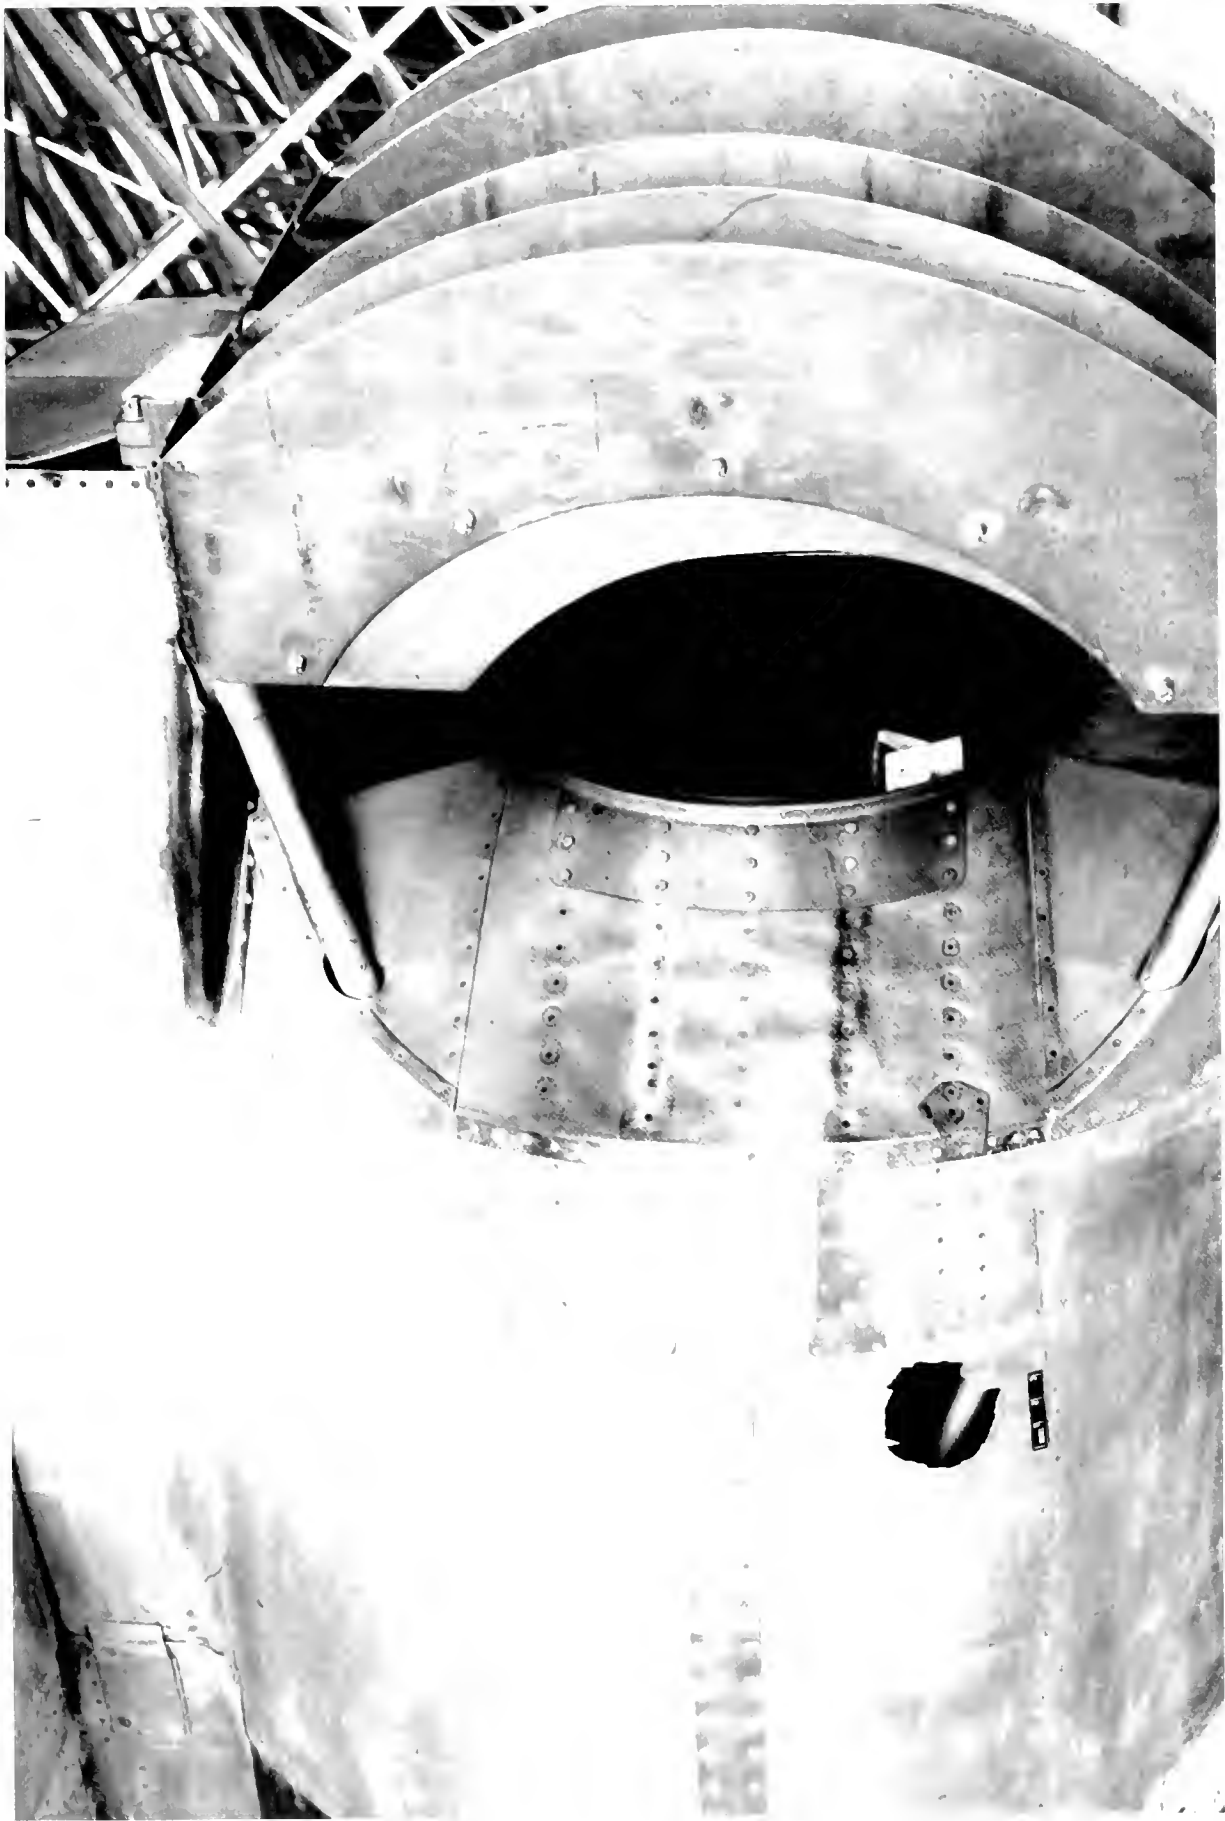
Figure 6-1. Close-up of damage to rear fuselage of F-94C Starfire caused by hot engine exhaust gases during prolonged use of thrust reverser in landing rollout. Fairing to cover rear portion of reverser has yet to be added. (Sept. 1957) A-23157

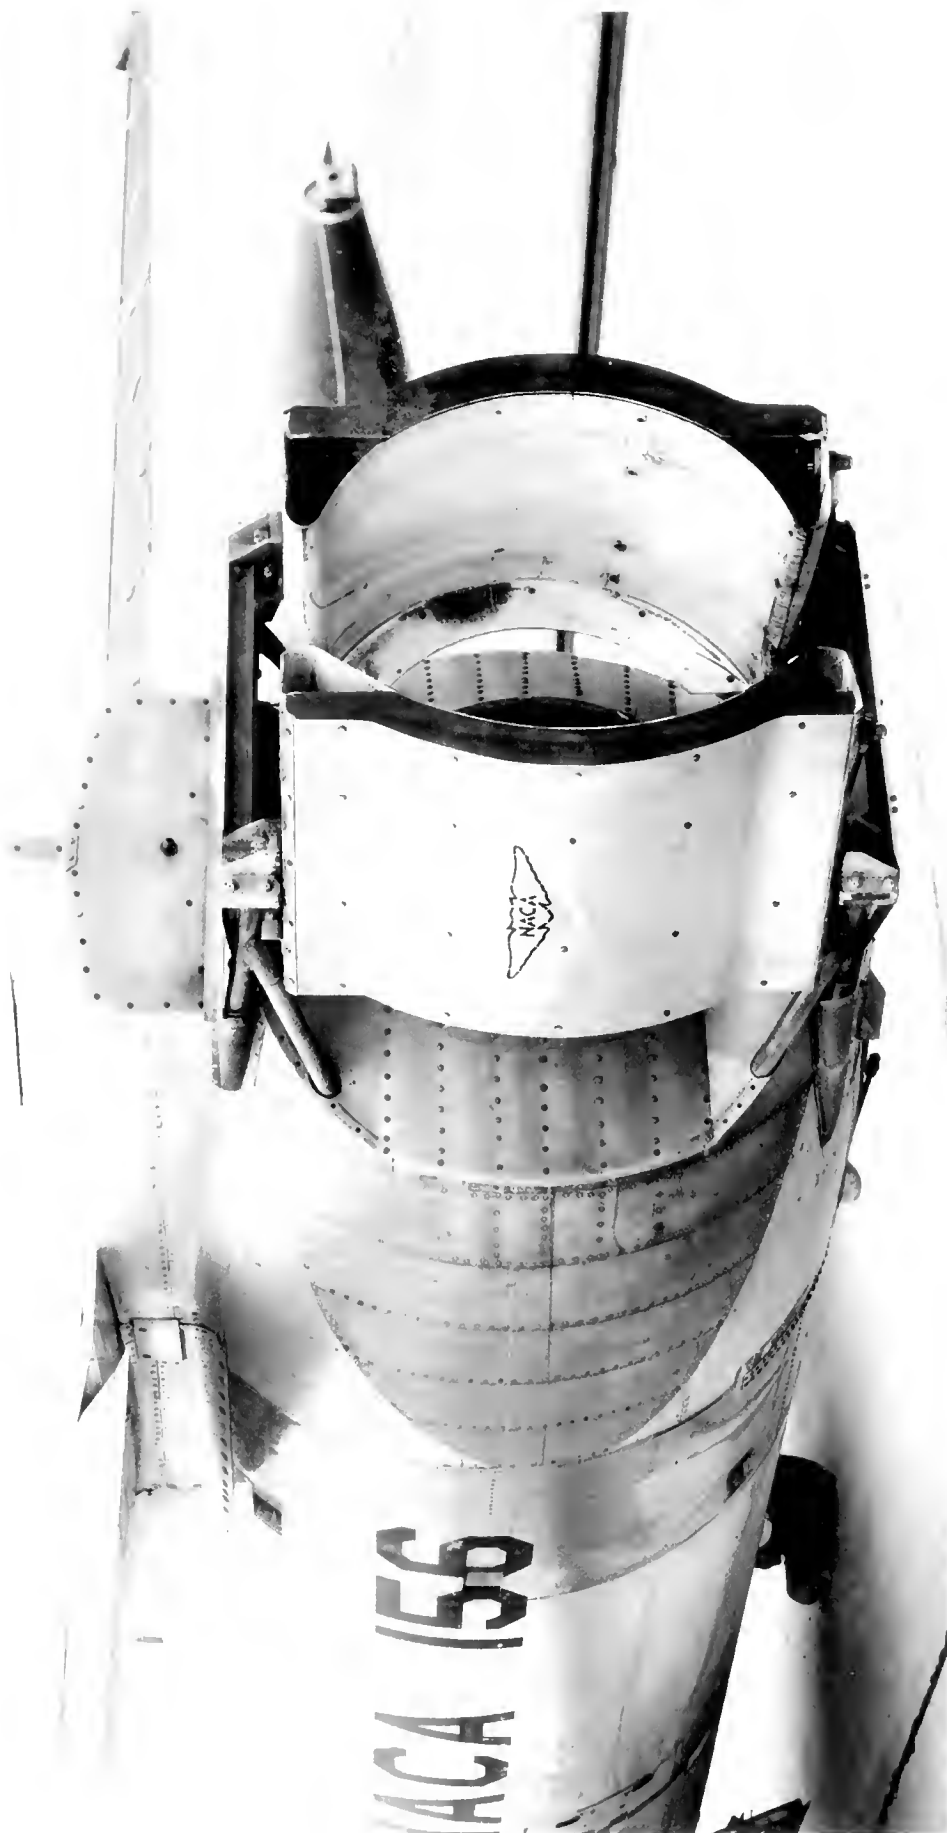
Figure 6.2. Close-up of target-type thrust reverser in forward thrust position (on F-94C Starfire). Titanium skin was added on the rear fuselage to withstand high-temperature environment. (1958) A-24153-2A

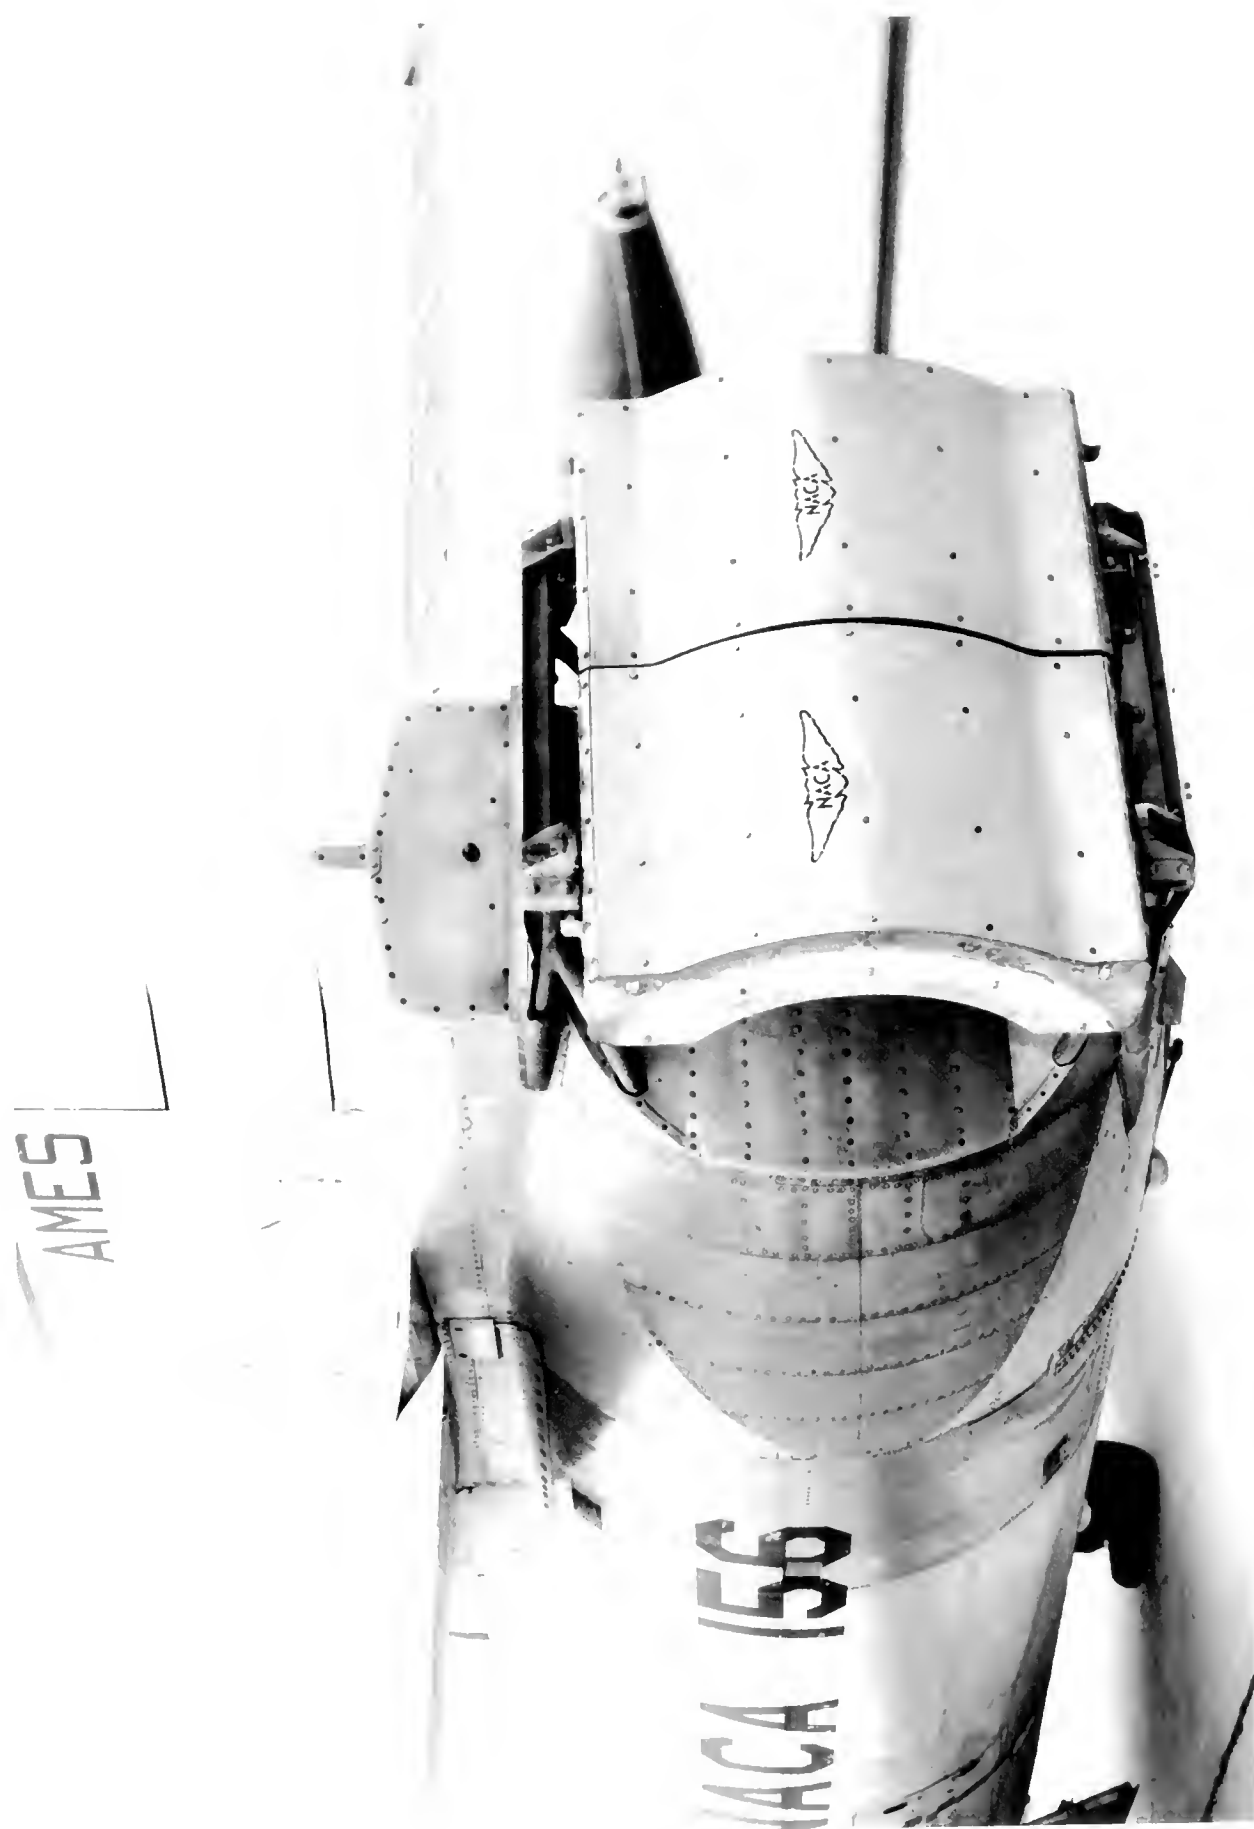
Figure 6.3. The thrust reverser on the F-94C Starfire was moved by an Ames-developed hydraulic actuator system. (1958) A-24153-1B

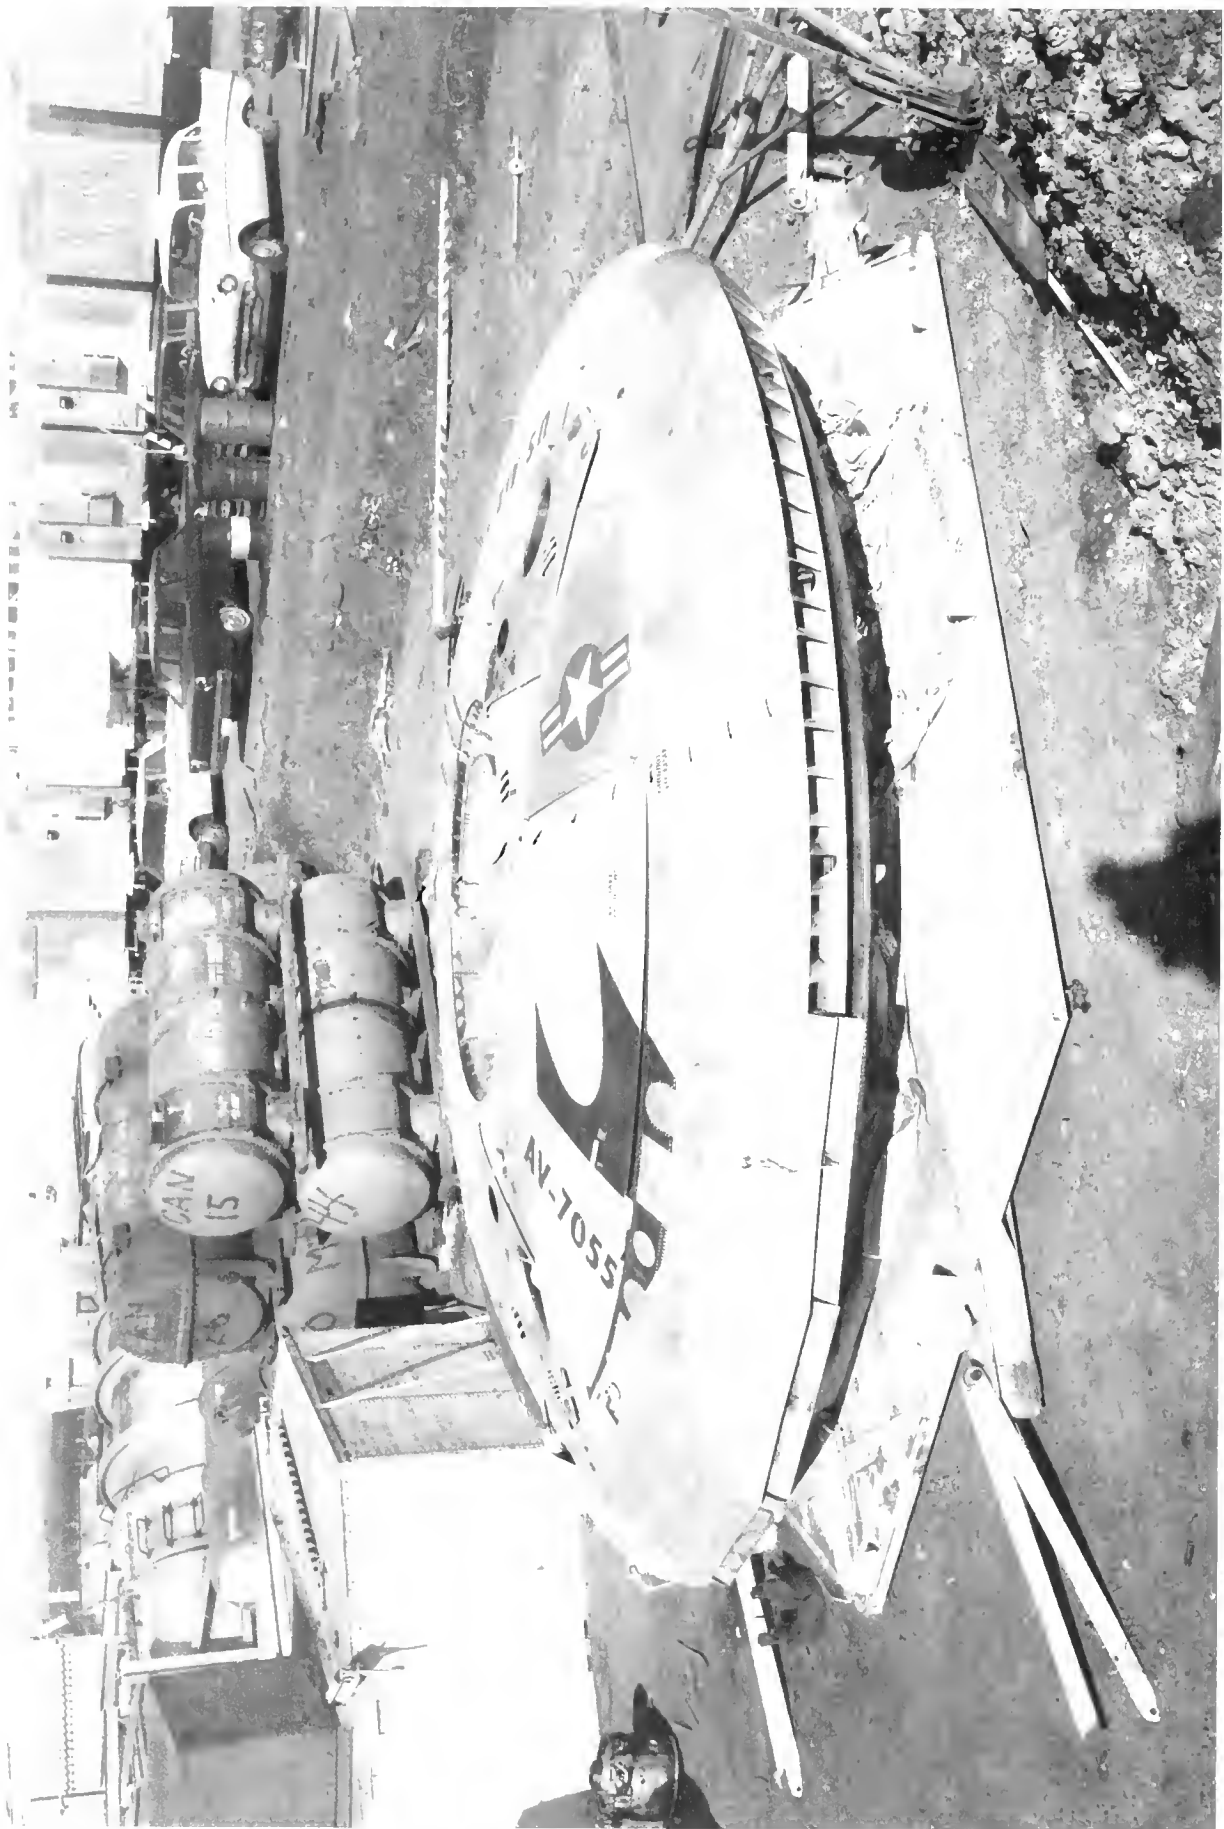
Figure 68. A five-foot-diameter fan at the center of the VZ-9-W VOTL vehicle provided vertical lift and airflow to louvers and vanes at the periphery for thrust-vector attitude- and translation control. The aircraft was not a success. An Ames test pilot called it a 3,000-horsepower sneer. (Doc. 1959) A-36414

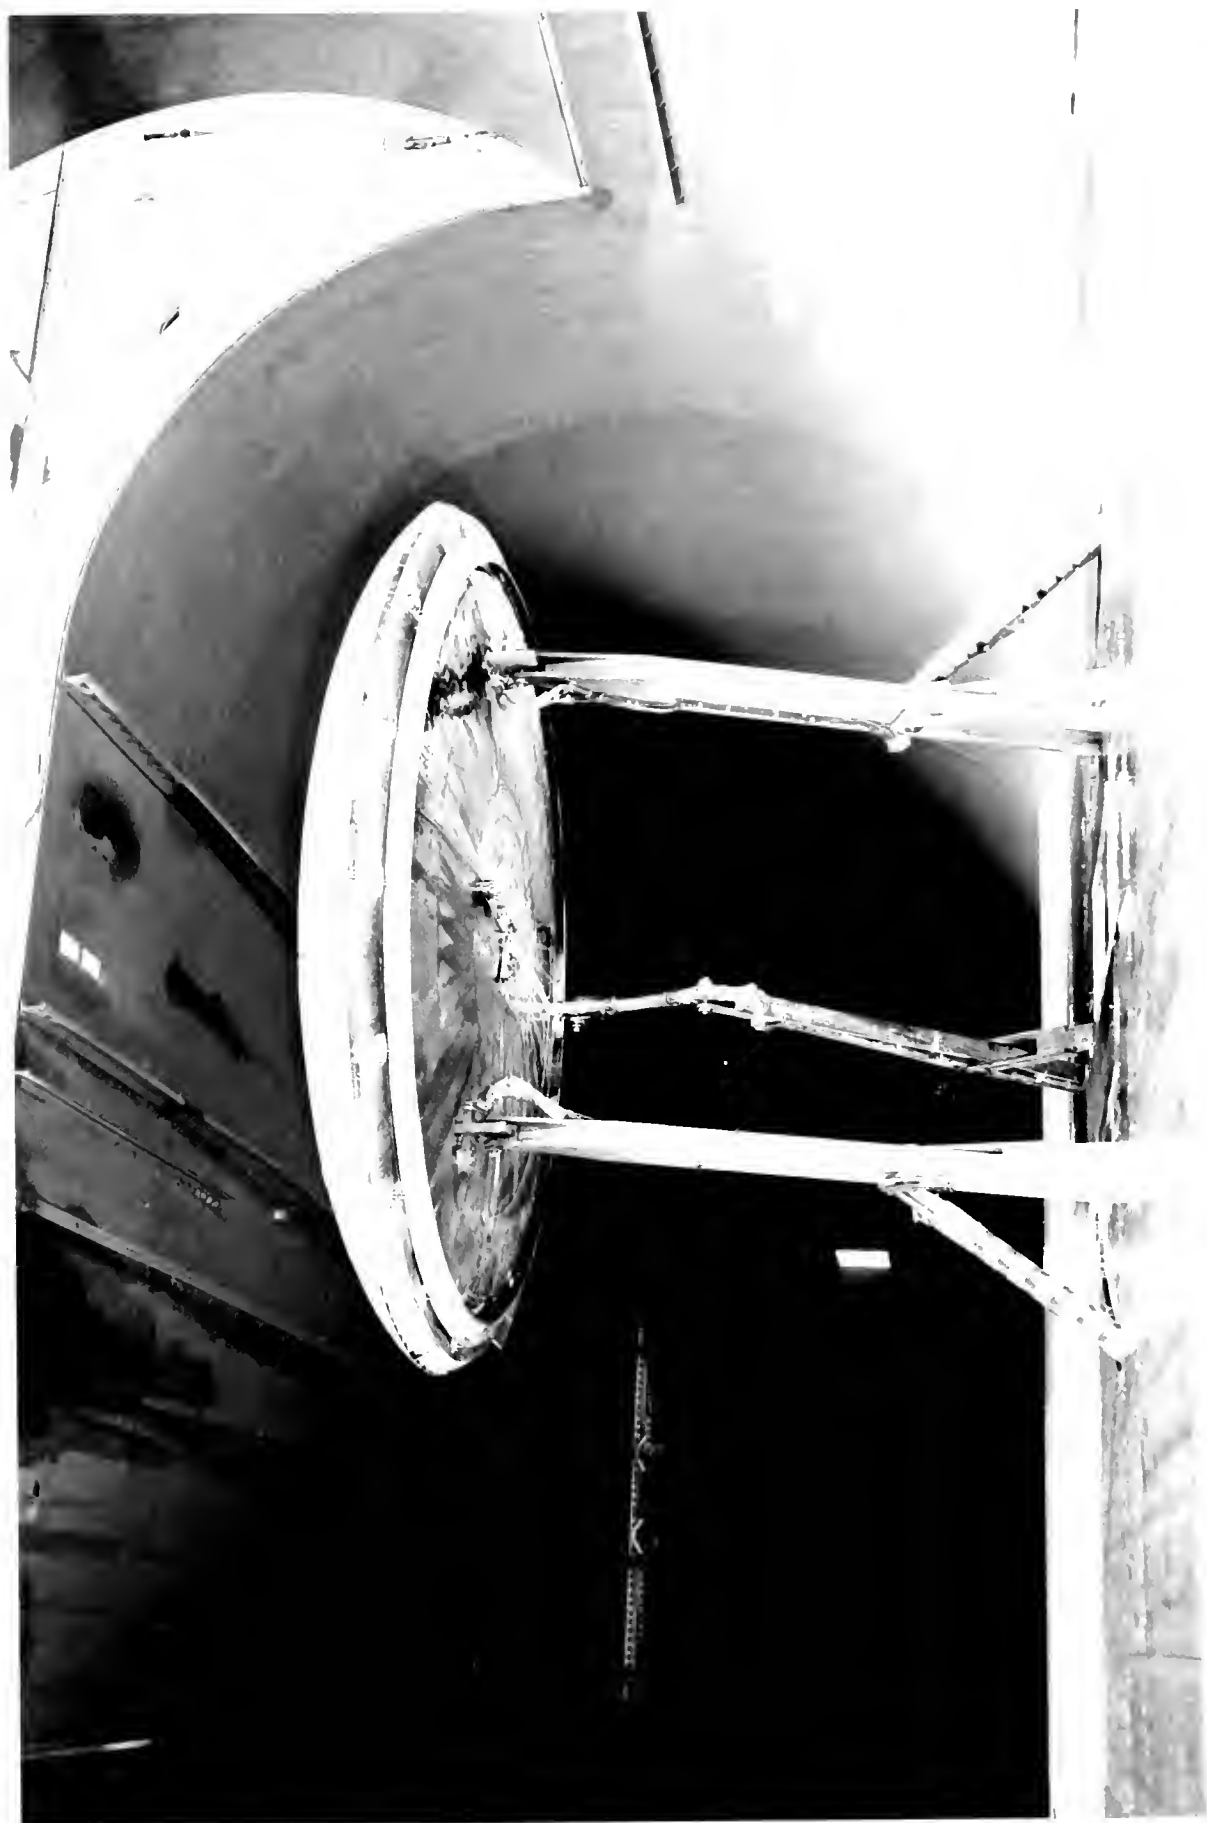
Figure 69 The eighteen-foot-diameter VZ-9W V-101 vehicle mounted in the 40- by 80-foot wind tunnel at Ames for measurements of aerodynamic characteristics. At best the cruise lift-to-drag ratio was about 4. Flight tests disclosed that dynamic instabilities prevented transition to conventional flight (Jan. 1963) V-27-46
